RAR2018

# Proceedings

# Road Pavement Preservation Trial with Reacted and Activated Rubber at JORR W2 Toll Road- Indonesia

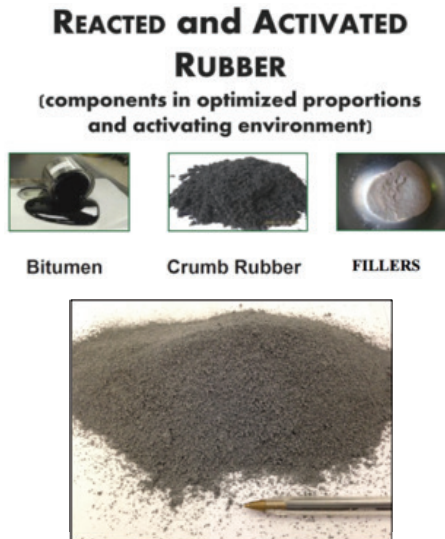
**Figure 2:** *RAR Composition*

Advancement in technology brought Reacted and Activated Rubber (RAR) technology, which is a pre-processed Crumb Rubber, already swelled with bitumen, (Sousa, 2015), Figure 2. Conventional AR has to be mixed inside a special blending plant and continued in a reaction tank to swell the Crumb Rubber within the binder. With RAR, those processes are no longer required and thus can be directly mixed with the available plant.

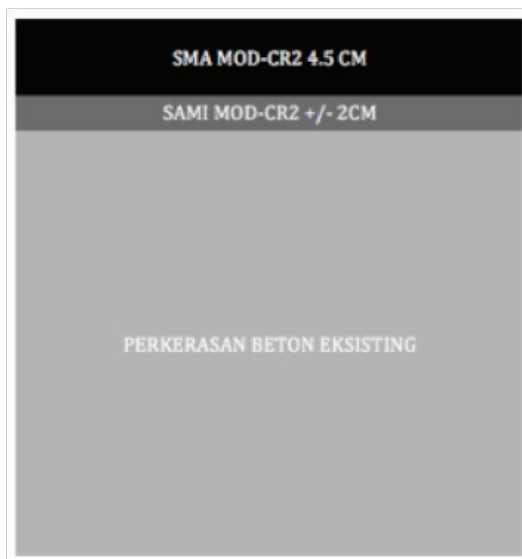
Figure 5: Pavement composition with rehabilitation strategy

The particular reason to use a 20 mm chip is presented in Figure 4. The chip covers the crack/joint converting the shear stress over the crack tip into compression stresses over the chip thus reducing significantly the crack intensity effects. Figure 5 shows the thickness of SMA and SAMI sections on top of the cracked concrete pavement.

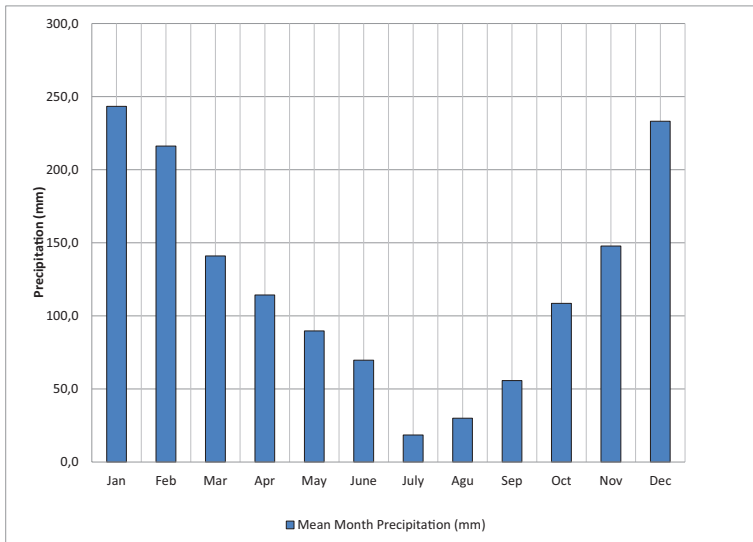
**Figure 6:** Mean Month Precipitation for Jakarta (2000 and 2011)

Figure 6 shows that Jakarta is an area with a considerable average monthly precipitation, mainly in the months between October and April, so the behavior of pavements is naturally influenced by water status in granular materials and soils of the foundation, when there isn't an adequate drainage system. To mitigate this effect a waterproof SAMI membrane was designed and built over all the pavement platform. Nevertheless, future improvement would lead to waterproofing the median and the shoulders and part of the embankments.

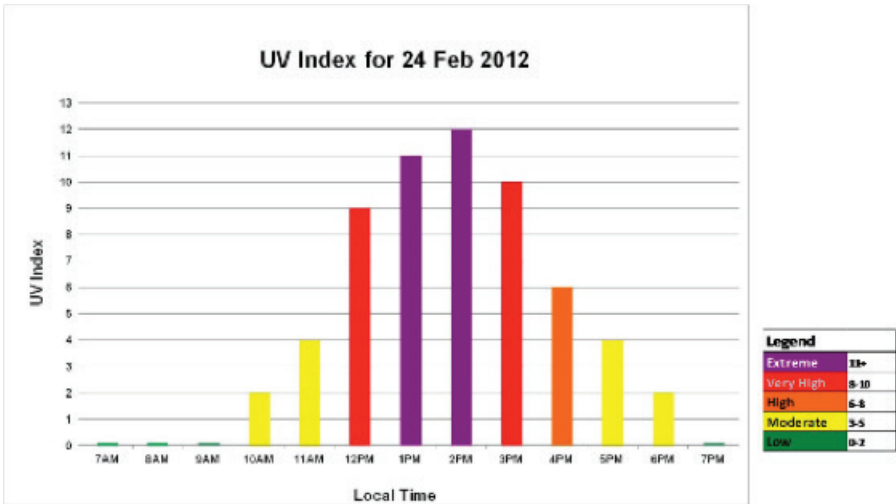
Figure 9: Example of UV index daily variation in Jakarta

It is common for the UVI to reach Very High and Extreme levels in the four hour period between 11 am and 3 pm on a day with little cloud cover, as in Jakarta, Figure 9.

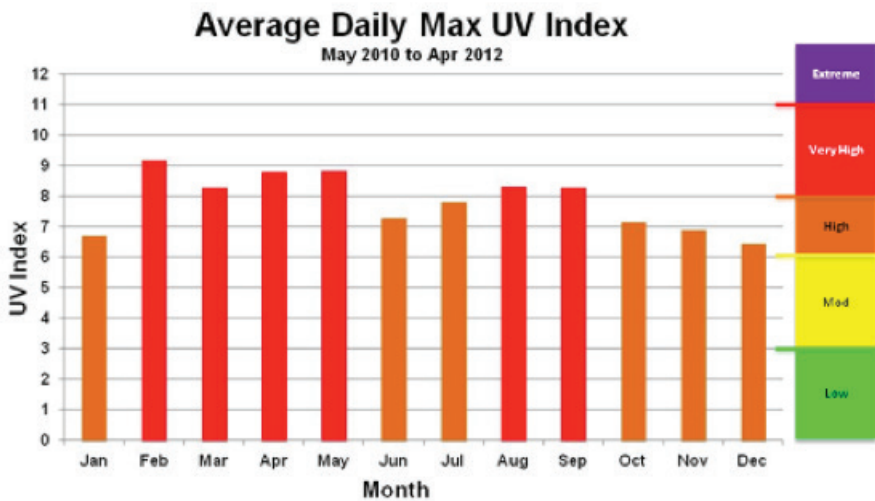
Figure 10: Variation of UV levels in Jakarta

UVI values are higher during months where there is less cloud cover and when the position of the sun is directly over the equator. Figure 10 below depicts the average variation of daily maximum UVI values across the year for Jakarta.

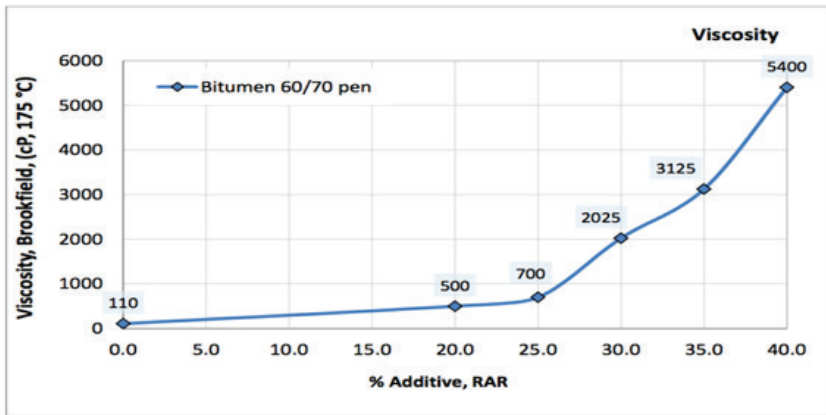
**Figure 12:** Binder Viscosity to RAR Proportion in Binder

Due to limitation of binder viscosity that can be sprayed evenly with the Asphalt Distributor pump, the optimum RAR proportion for SAMI work was adjusted a few times (the target was to spray binder at 2000 to 3000 cP), Figure 12:

- a. Day 1: 71.5% Pen 60/70, 28.5% RARX
- b. Day 2: 68% Pen 60/70, 32% RARX
- c. Day 3 & 4: 70% Pen 60/70, 30% RARX

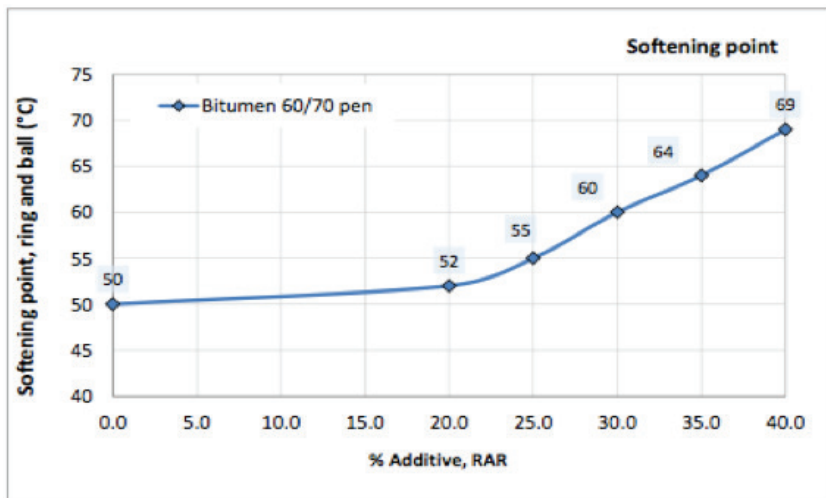
**Figure 13:** Binder Softening Point to RAR Proportion in Binder

Binder proportion in SMA (GAP GRADED gradation) was 65% Pen 60/70 and 35% RARX. This was determined through lab testing to determine softening point, Figure 13 and PG Performance Grade, Figure 14.

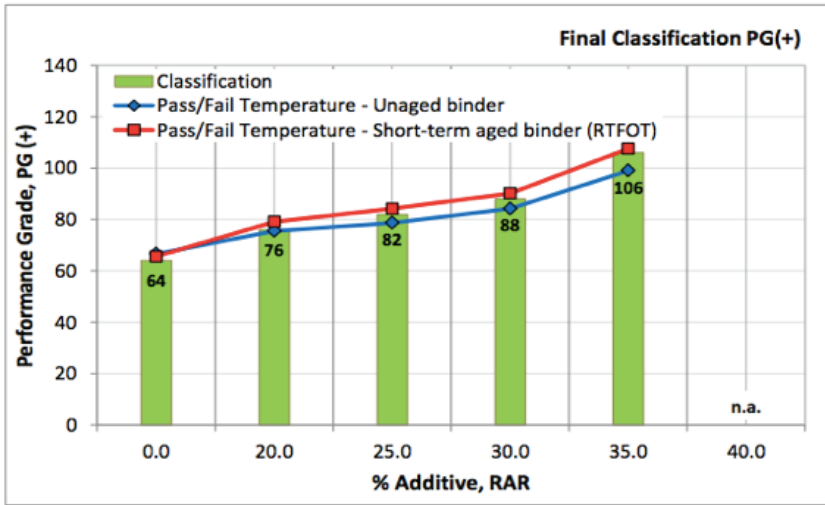
Figure 14: Performance Grade to RAR Proportion in Binder

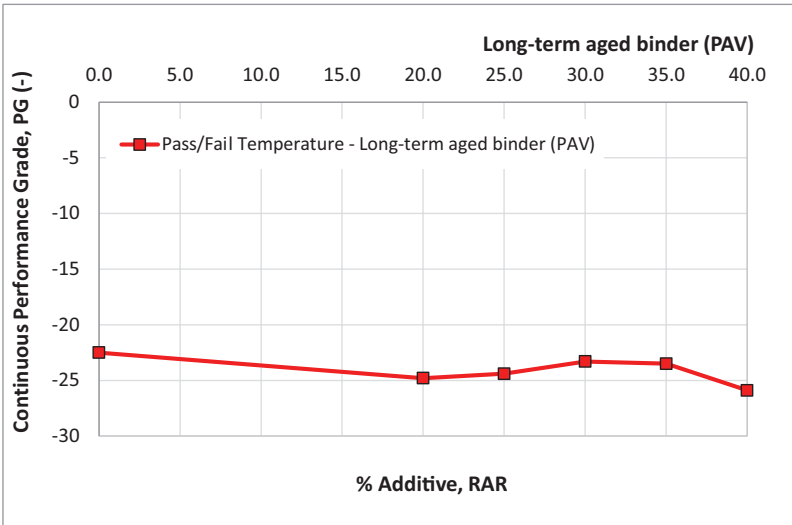
Figure 15: Continuous Performance Grade, PG (-) (long-term aged binder, PAV)

Partial values after PAV aging are presented in Table 1. Figure 15 and Figure 16 show graphically the influence of RAR percentage on long-term aged binder performance and final classification [Performance Grade, PG (-)].

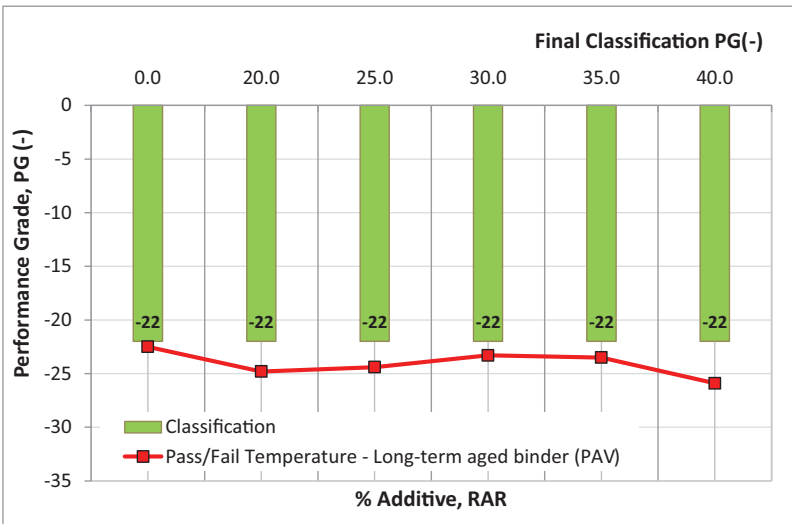
Figure 16: Final Classification, PG (-)

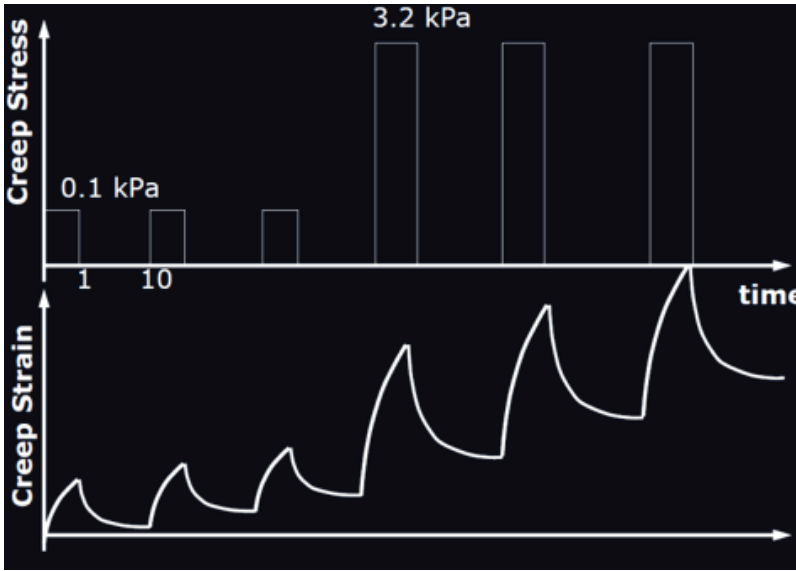
**Figure 17:** MSCR loading and deformation typical patterns

The Multi Stress Creep Recovery (MSCR) accordingly to AASHTO TP 70 gives an indication of the quality of the binder in order to permanent deformation resistance and general ability to recover from deformation. Loading is applied as presented in Figure 17.

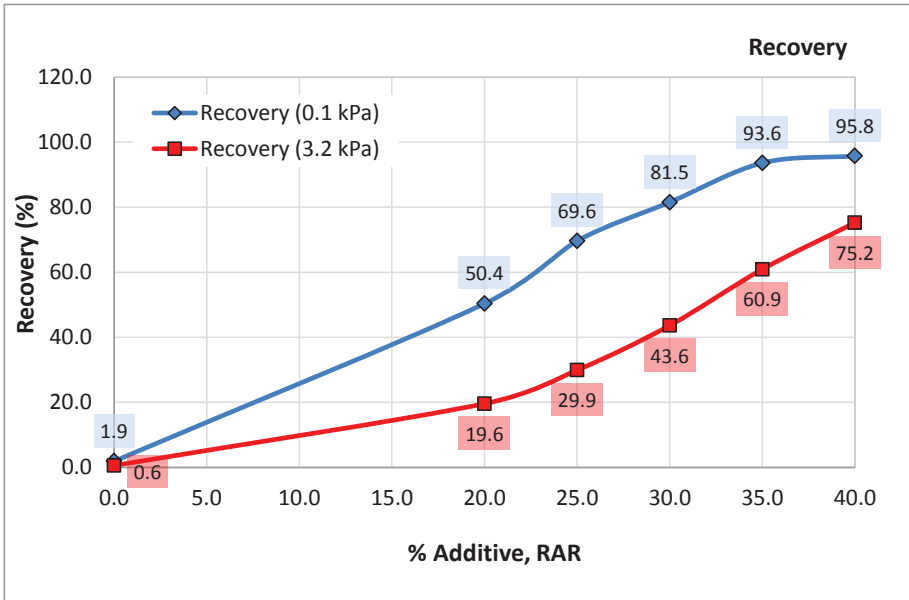
Figure 18: Recovery results at 0.1 kPa and 3.2 kPa

Table 2 presents a summary of Jnr testing and Figure 18 to Figure 19 presents the graphically results.

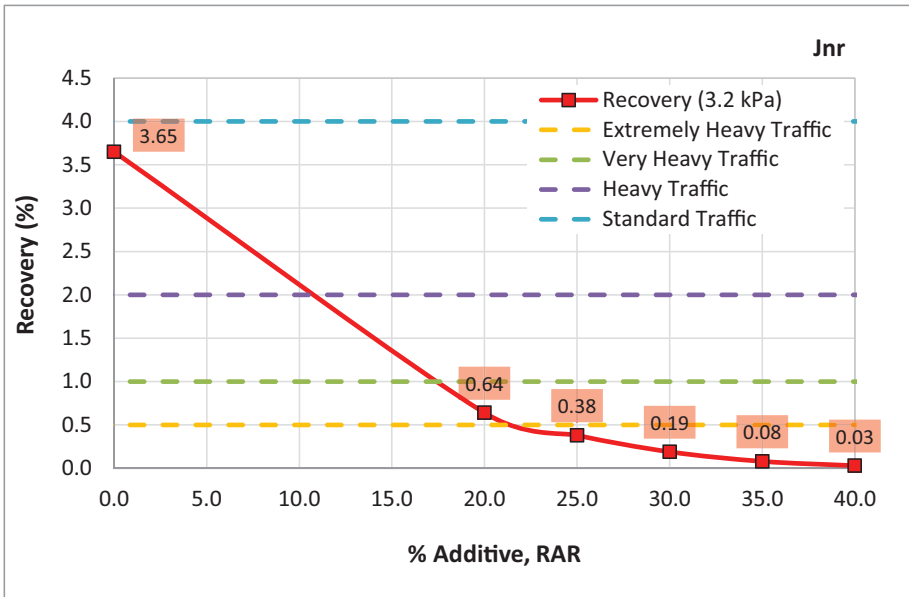
Figure 19: Jnr at 3.2 kPa values function of the RAR percentage versus traffic type

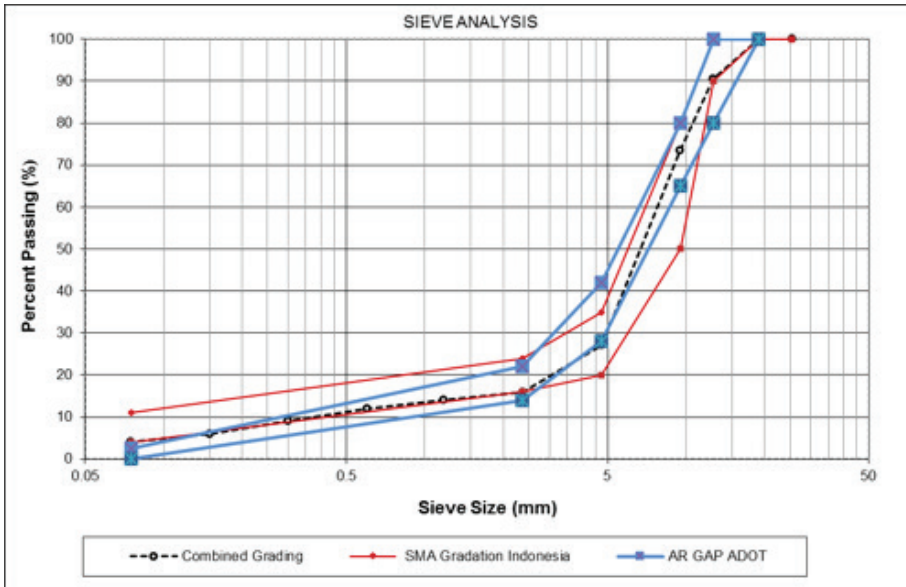
Figure 20: Gradation of RAR - GAP GRADED

The aggregate gradation curved used was designed to fit an ADOT Gap Graded with maximum aggregate size of 19 mm, Figure 20.

The gradation was designed to be as coarse as possible within the SMA Indonesia grading curve to increase its VMA structure and to fit within the Asphalt Rubber Arizona Department of Transportation Gap grading curve such that more Asphalt Rubber binder can be accommodated in the mix. A new GAP graded gradation curve should be added to the mixes allowed with the Indonesia road network. Mix design information is shown in Table 3.

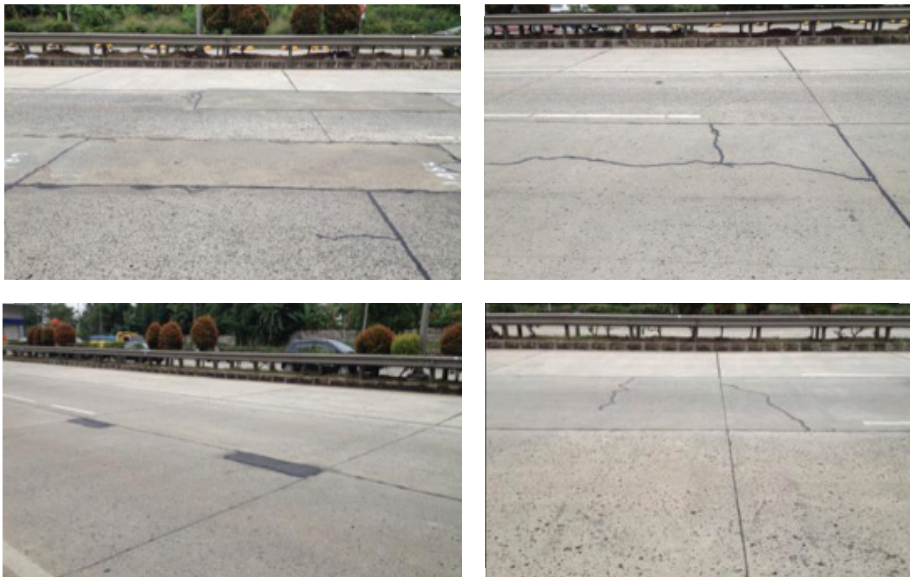
**Figure 21:** *Joint and Crack Sealing on Existing Pavement*

The trial was scheduled to be done in 3 days, however the realization required 4 days due to weather and traffic condition. Figure 21 shows cracked condition of concrete pavement before overlay.

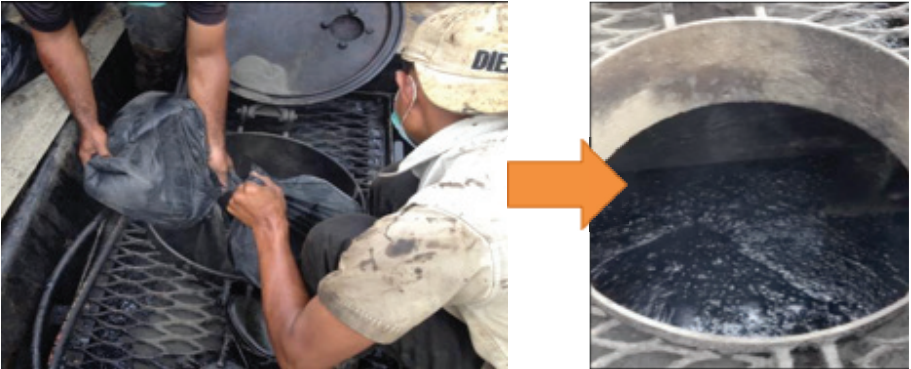
**Figure 23:** Binder preparation (adding RAR to the bitumen) at 175-185°C

Bitumen Pen 60/70 and RAR mixing was done directly inside the Asphalt Distributor tank which was equipped with mixer system. Bitumen Pen 60/70 was put into the tank at 190°C, added with RAR at ambient temperature. The temperature was maintained at 175°C during mixing. Figures 23-27 show mixing of RAR and hot asphalt followed by placement of the SAMI over the concrete.

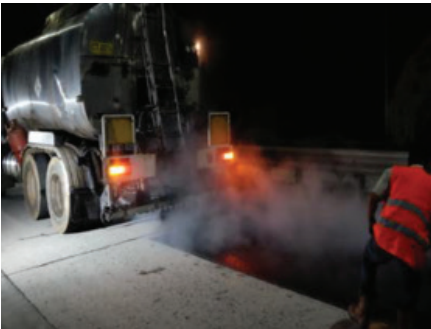
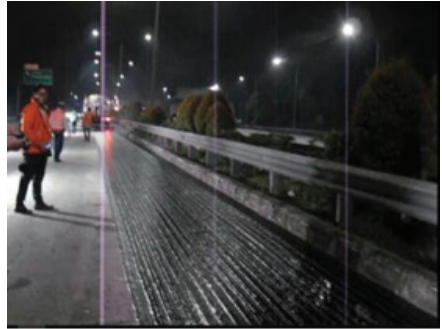
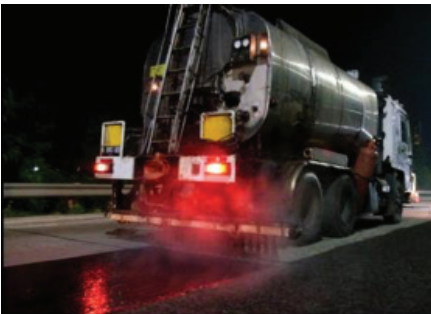
**Figure 24:** Binder spraying

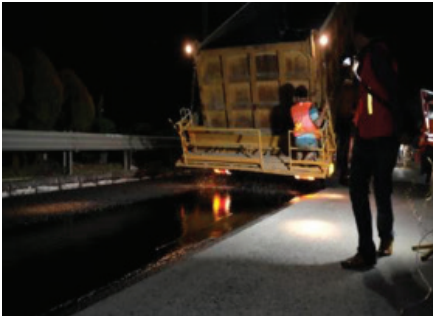
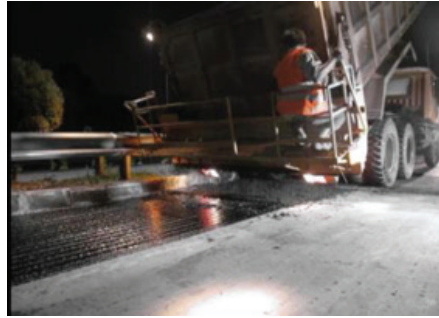
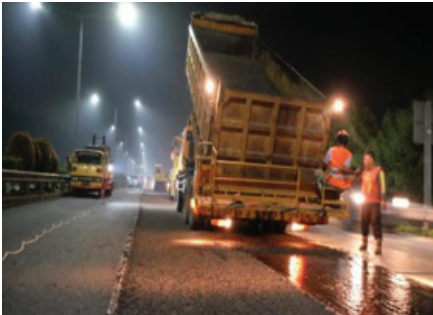
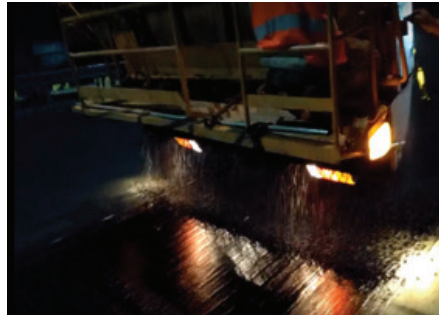
**Figure 25:** *Precoated chip spreading directly after binder spraying at 120°C*

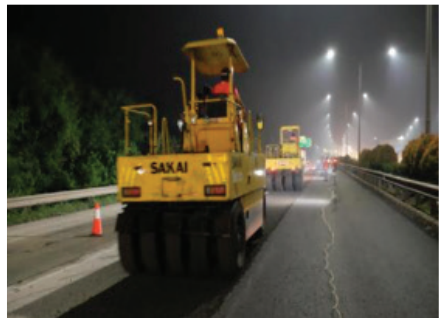
**Figure 26:** *Continued with rolling which had to be finished within 20 minutes after spraying*

After rolling, the SAMI was let to cool down for about 30 minutes to 1 hour. Then continued by cleaning the loose material using Power Broom.

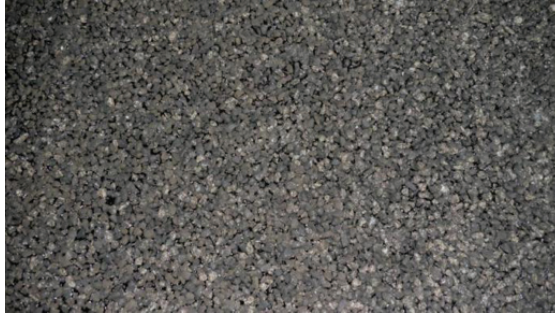
**Figure 27:** Visual of SAMI Mod-CR2

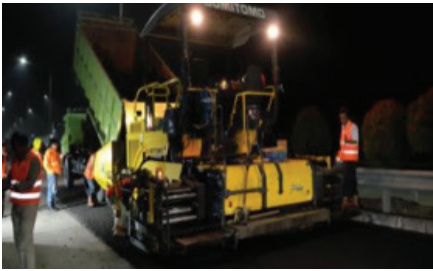
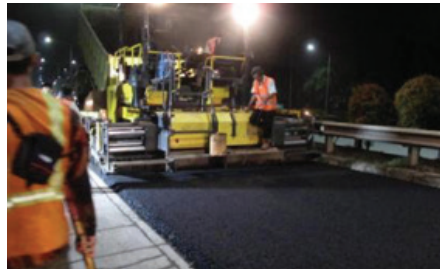
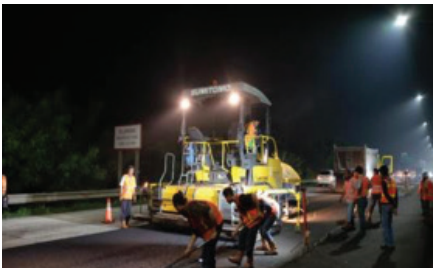
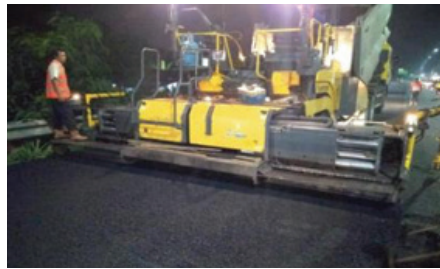
**Figure 29:** *Laying on site at 170°C*

The mix in Dump Truck was at 190°C. During delivery to site, there was about 5-10°C temperature drop per hour. Figures 29-33 show the placement and final Asphalt Rubber SMA surface.

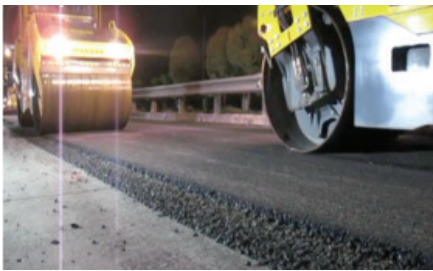
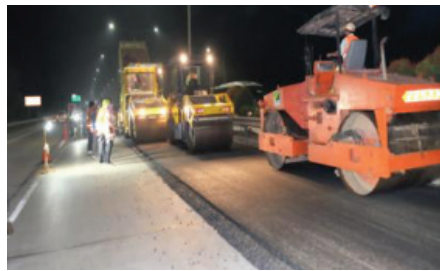
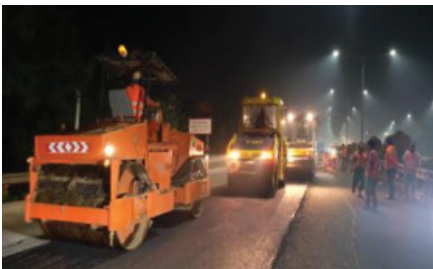
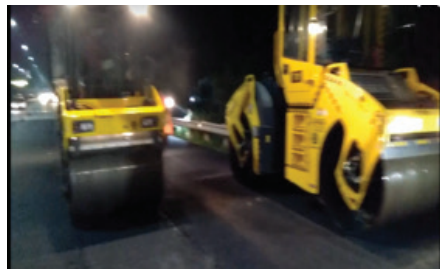
**Figure 30:** *Compaction passes referring to Trial Compaction result*

Rolling temperature range from 170°C to 120°C. Below 120°C, the viscosity would be very high that rolling was not effective.

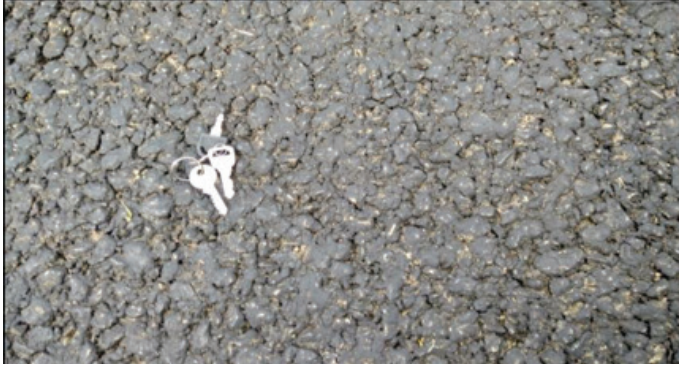
**Figure 31:** *Visual of SMA Mod-CR2*

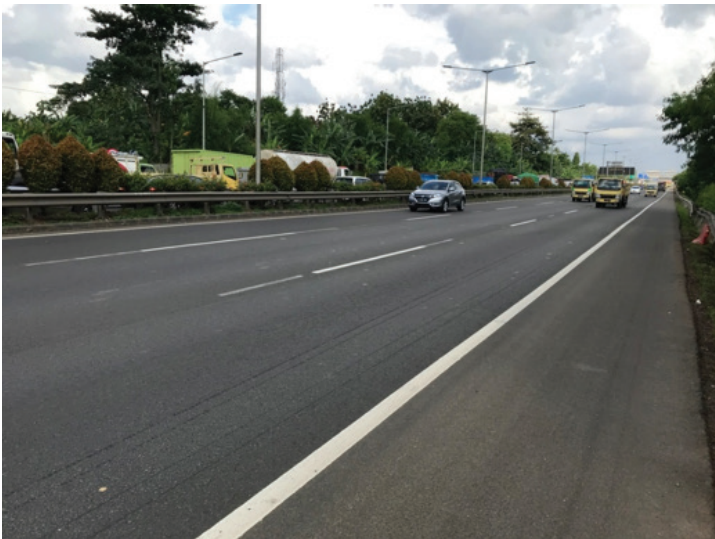
**Figure 34:** *Trial section after 18 months of traffic*

After 18 months subjected to traffic, rain and UV the overlay is still in perfect condition, Figure 34. Only one spot developed a pot hole, Figure 35. This pot hole was found on a location where core sample was taken, indicating improper filling material/procedure. For comparison purposes Figure 36 shows an adjacent regular hot mix section built 2 months later which already has multiple potholes and extensive reflective cracking. This conclusively demonstrates the effectiveness of adding reacted and activated rubber to rehabilitation strategies.

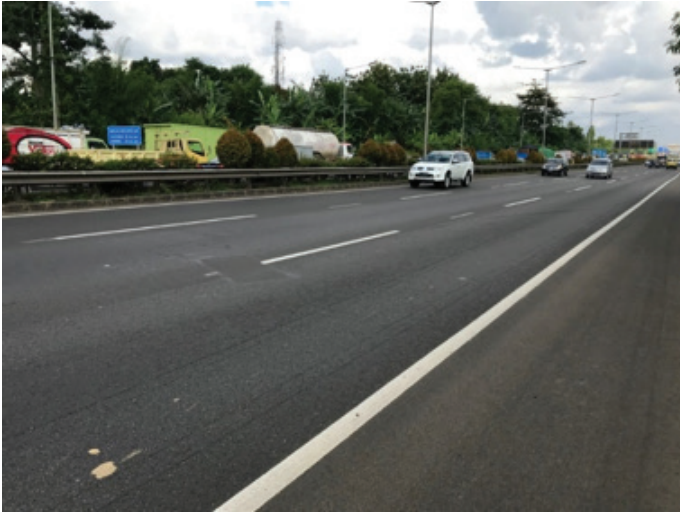
**Figure 35:** *Patched Pothole*

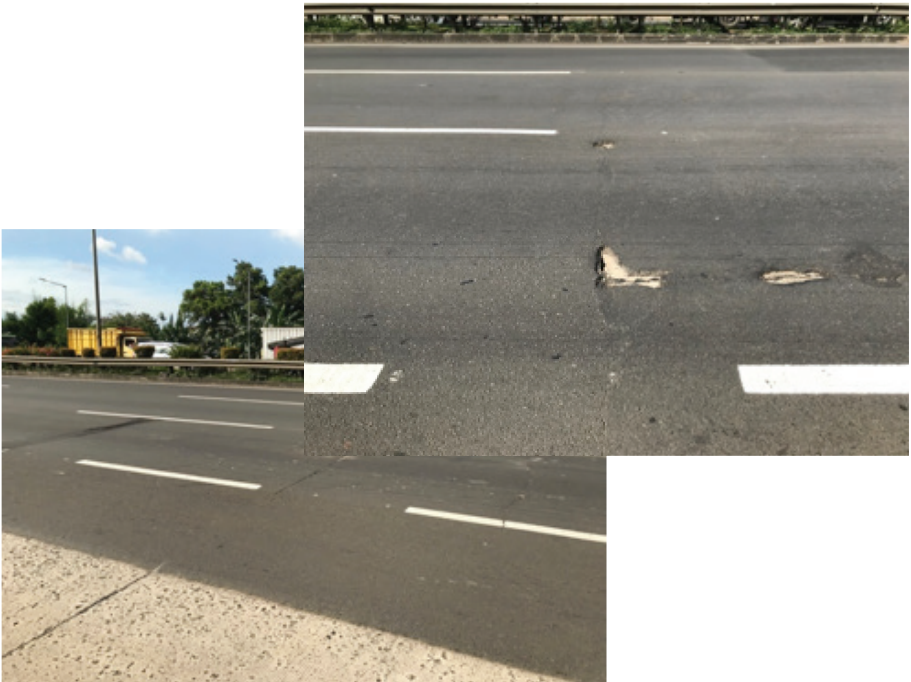
**Figure 36:** *For comparison see Adjacent with the same pavement structure, same condition, and same traffic but with a Conventional Hotmix Section which is 2 months newer than the trial section and already has reflective cracks and many potholes*
